# GLOBAL ETS

NEXT GENERATION COMPONENT TESTING & AUTHENTICATION

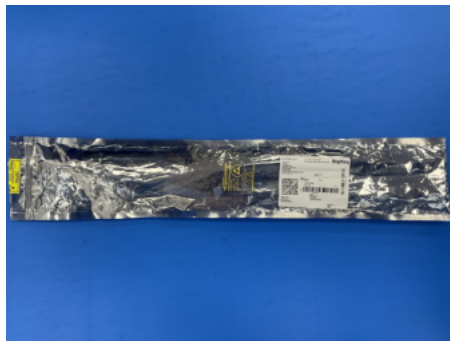
**Figure 1. INCOMING 1**

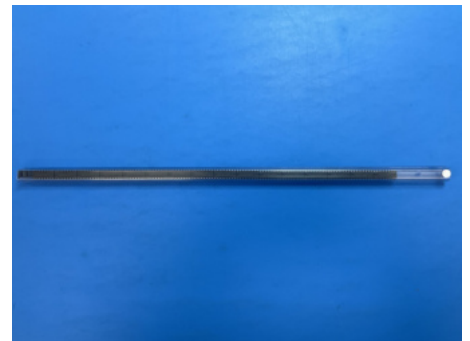
**Figure 3. INCOMING 3**

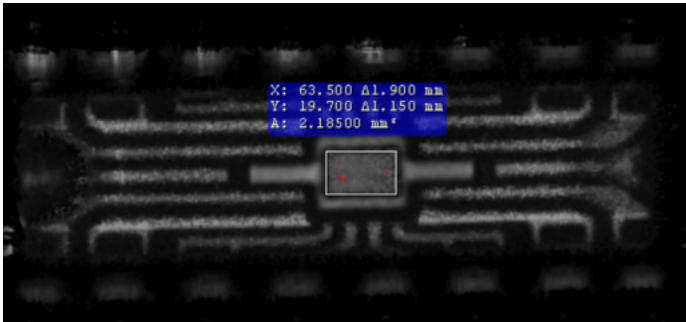
**Figure 57. DUT SCAN DIE/PAD INTERFACE**
