GLOBAL ETS

NEXT GENERATION COMPONENT TESTING & AUTHENTICATION

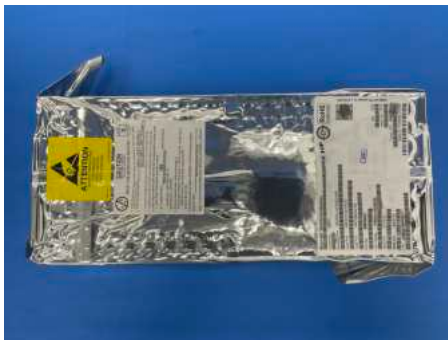
Figure 1. INCOMING 1

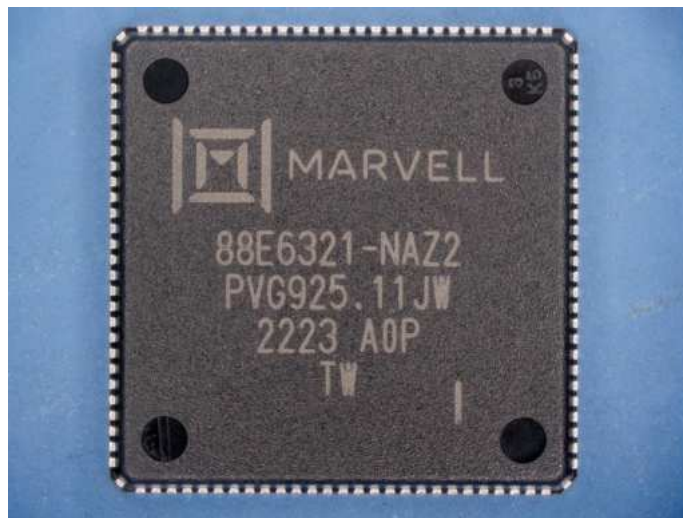
Prepared by:	Disclaimer	Generated On:
	<p>Global Electronics Testing Services, LLC Florida is dedicated to ensuring the highest standard of product testing in the industry and extend every effort to report reliable data and an accurate interpretation. However in no event shall Global Electronics Testing Services, LLC USA be liable any special, indirect or consequential damages or any damages whatsoever resulting from loss of any kind including profits, in any action arising out of or in connection with the test report or data associated with the report.</p> <p style="text-align: center;">Global Electronics Testing Services, LLC 2631 Success Dr., Odessa, FL, 33556, USA 1-727-807-7991</p>	
Approved by:		Page:
 (JASON HOUSTON)	Page 6 Of 16
